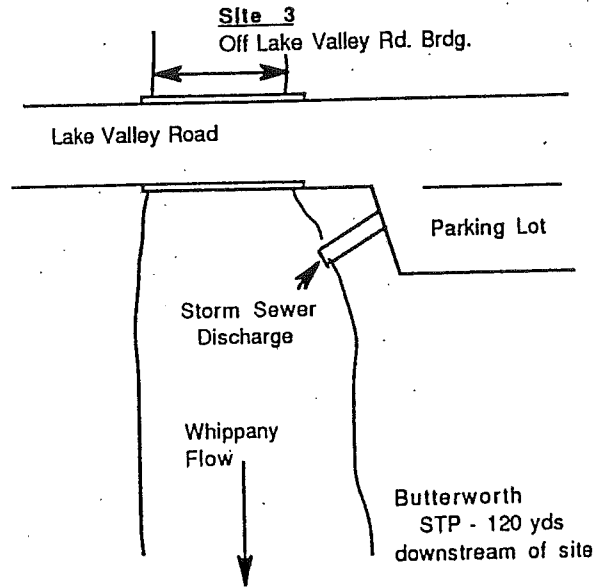
LOCATION: Lake Valley Rd. Bridge, 120 Yds.
upstream of Butterworth STP Outfall

OBSERVATIONS: Bridge sample
Stream Width 28 ft. ave.
Stream Depth 5 ft. ave.

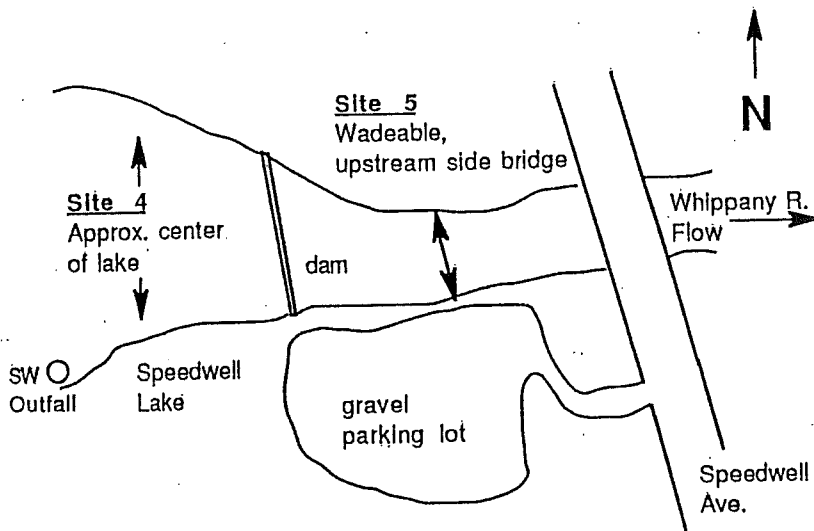
LOCATION: Upstream side of Speedwell Ave. Bridge

OBSERVATIONS: Wadeable, rocky bottom
Stream Width 40 ft. ave.
Stream Depth 1 - 3 ft. ave.

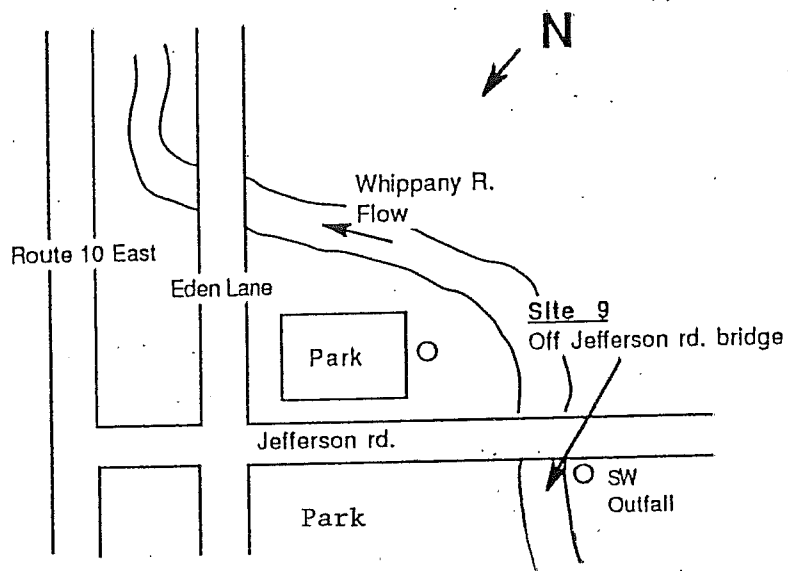
LOCATION: Jefferson Rd. near intersection with Eden Lane

OBSERVATIONS: Rocky bottom, steep banks
Stream Width 25 ft. ave.
Stream Depth 3-4 ft. ave.

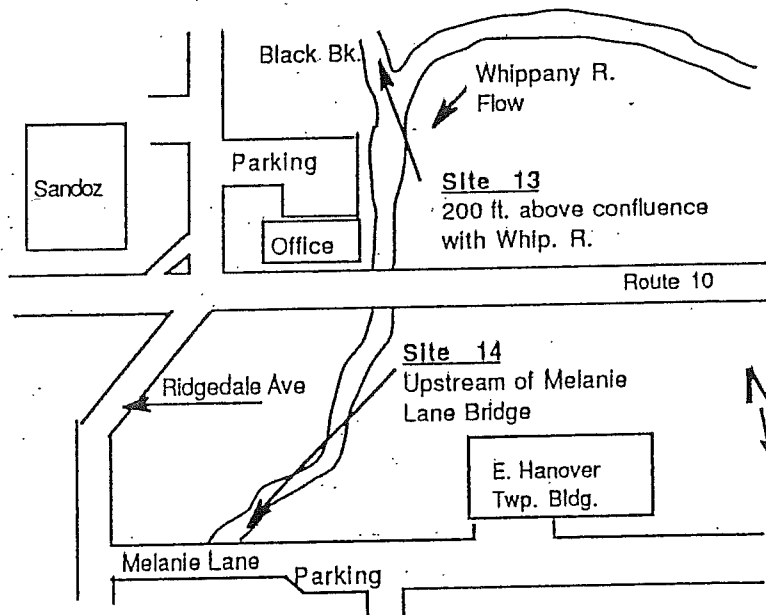
LOCATION: Off Melanie Lane, near Ridgedale Ave.

OBSERVATIONS: Wadeable, partial rock/mud bottom
 Stream Width 38 ft. ave.
 Stream Depth 4.5 ft. ave.

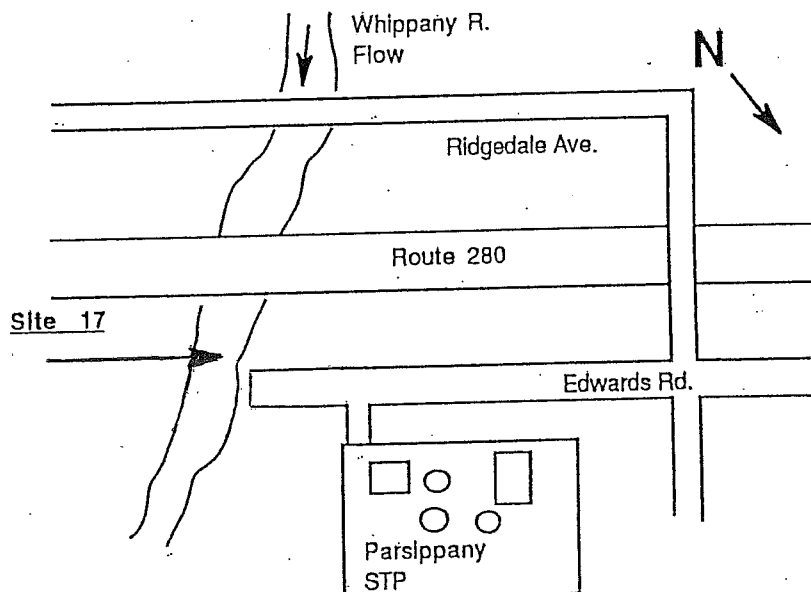
LOCATION: Edwards Rd. where it dead ends with Whippany R.

OBSERVATIONS: Hip boots needed, depth of water and mud vary
 by time of year and rainfall.
 Stream Width 35 ft. ave. Stream Depth 4.5 ft. ave.
